**Pilot Green Transport Fund**

**Final Report**

**Trial of Electric Light Goods Vehicle for**

**(New Method Cleaning Services Limited)**

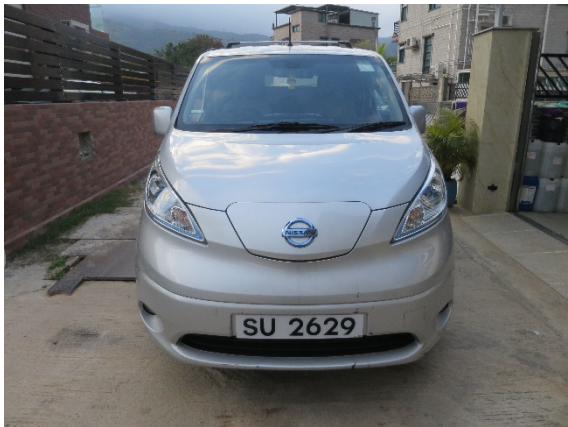
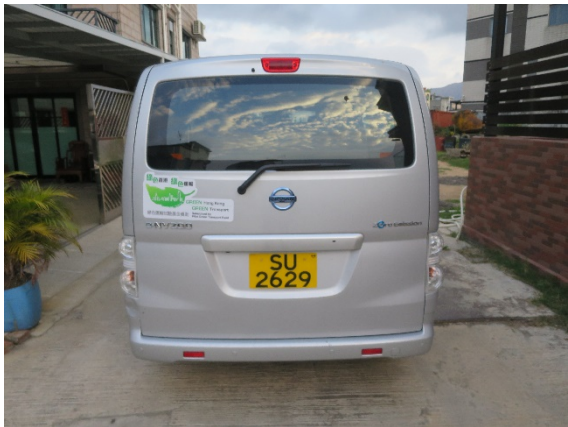
Front view of EV	Rear view of EV

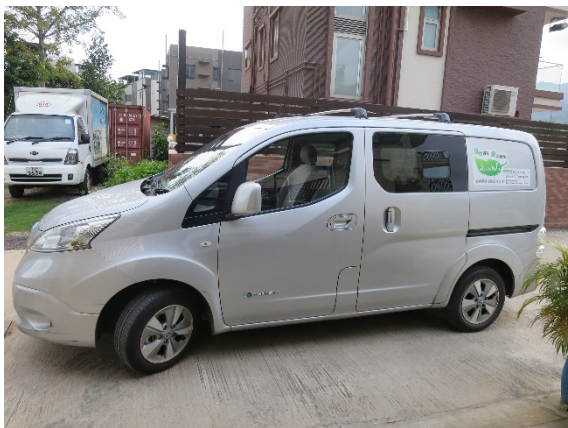
Left side view of EV	Right side view of EV

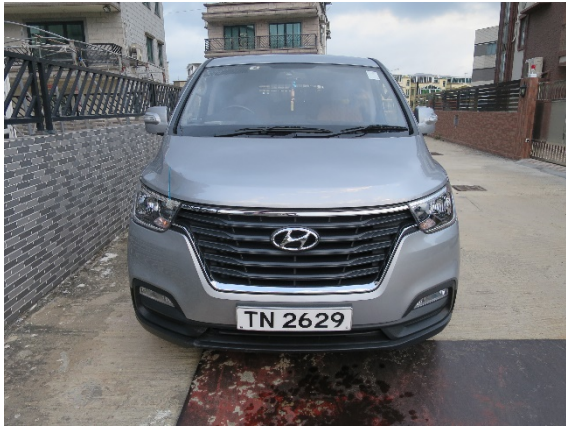
Front view of DV2

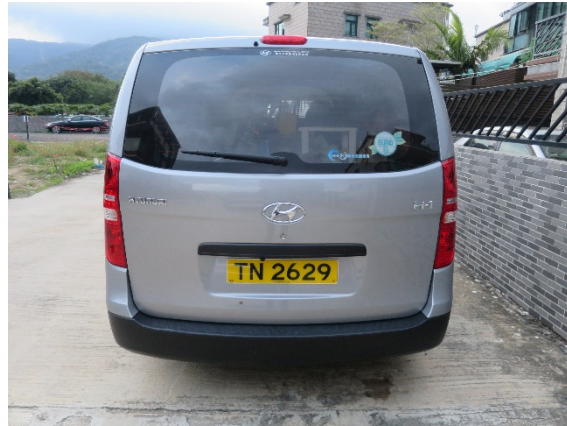
Rear view of DV2

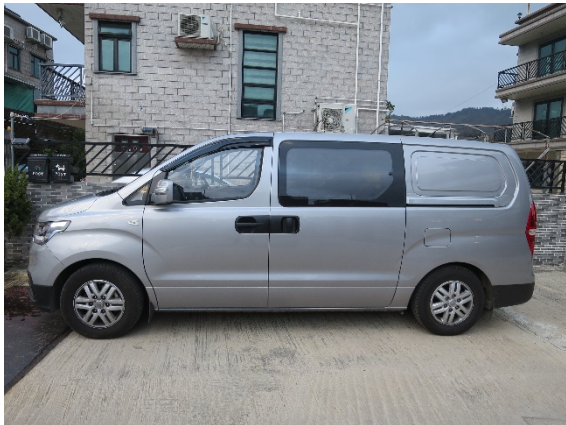
Left side view of DV2

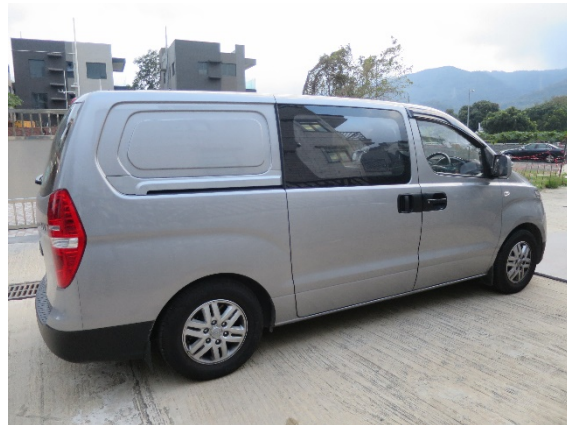
Right side view of DV2
